TECHNICAL DATA

Fluke ii910 and ii900 Acoustic Imagers

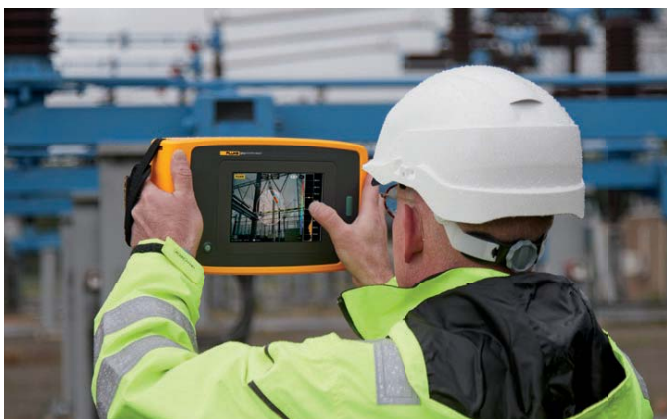
Image taken of the ii910 Precision Acoustic Imager detecting partial discharge in a high voltage application

Partial Discharge is a very serious issue that you would like to be able to monitor quickly and easily. Whether you are inspecting insulators, transformers, switch gears or high voltage powerlines you need to be sure that you spot a problem quickly and early. Partial discharge that goes unchecked can cause blackouts, fires, explosions, or death from arc flashes. In addition to the danger that partial discharge poses to human lives and the environment, there is a significant monetary risk of downtime. Having equipment go down can cost millions of dollars per hour of downtime.

The Fluke ii910 Precision Acoustic Imager is the perfect tool for high voltage electricians, electrical test engineers, and grid maintenance teams that are constantly inspecting and maintaining power distribution and industrial high voltage equipment. The ii910 provides a safe quick and easy way to detect and locate partial discharge in order to maintain high voltage equipment and prevent catastrophic events. With the SoundSight™ technology the ii910 translates the sounds that it hears into a visual representation so that you can quickly locate problem areas. The higher frequency capability of the ii910 allows for earlier detection to facilitate early maintenance planning and is why the ii910 has a frequency range of 2-100Khz.
